St Mary's Church Frampton

Roof Repair Project

October 2015 -
January 2016

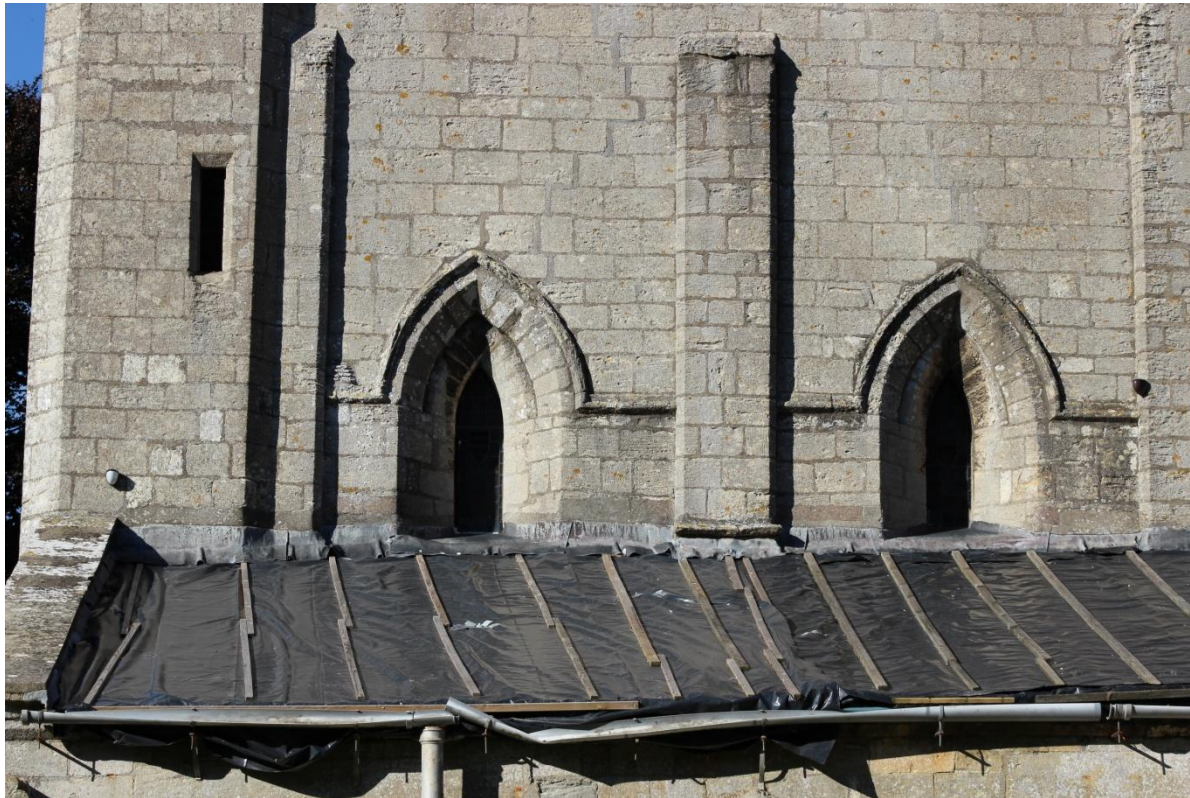
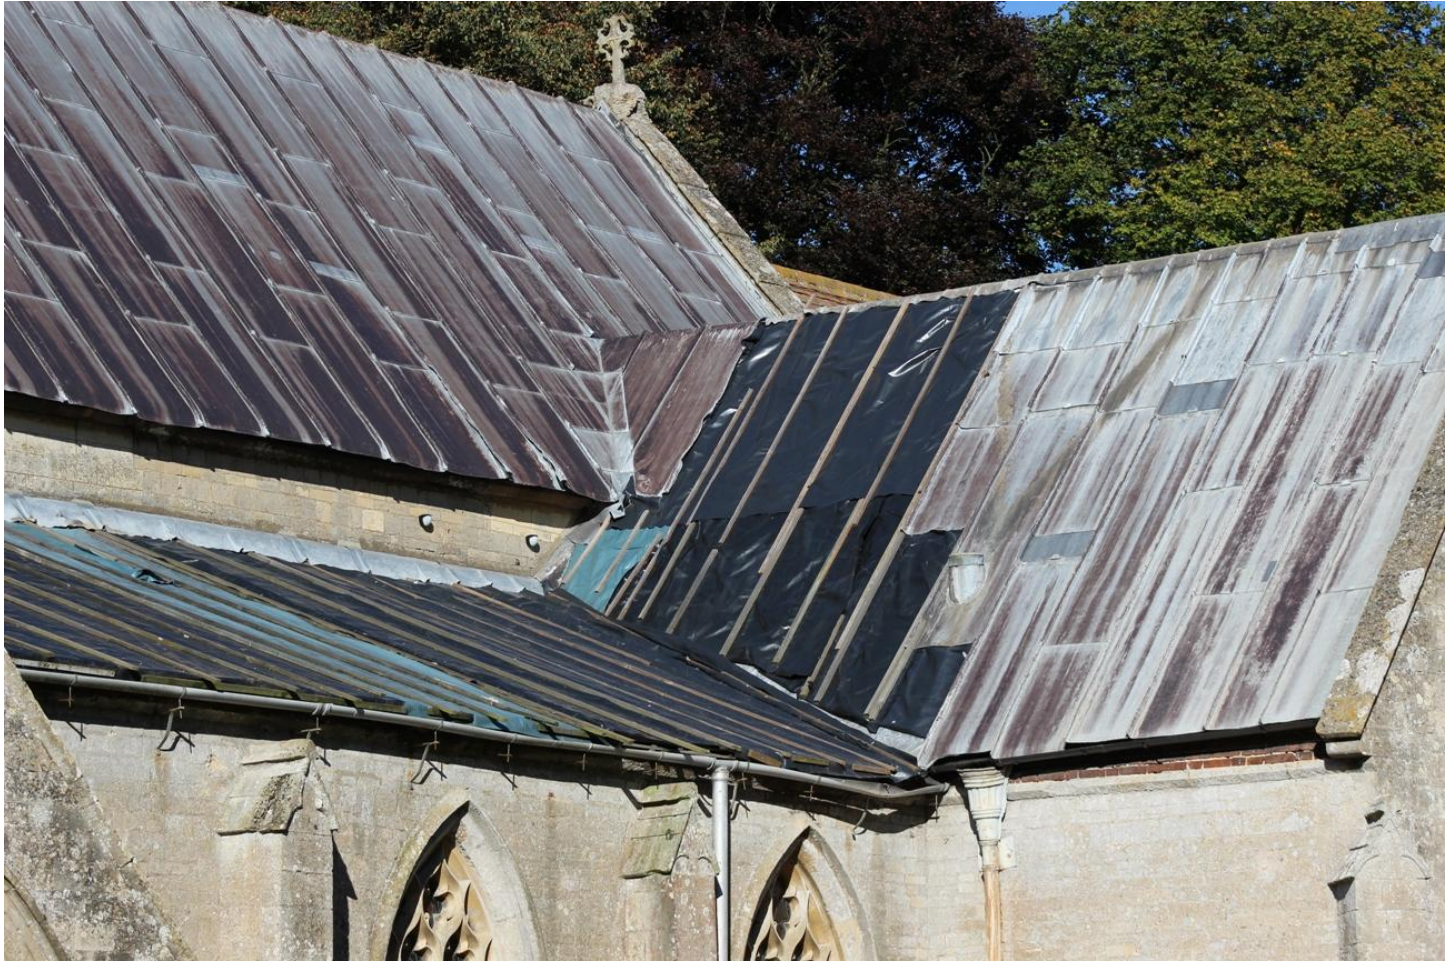
In 2014 there was a further attack when the lead over the Meeting Room area was stripped – allowing the rain to pour in on Palm Sunday (*despite new roof alarm*)!

The temporary roof covering of plastic sheeting was fitted to protect the roof timbers. It kept most of the rain out but a full repair was urgently needed!

Permission was sought to allow the stolen lead to be replaced with Terne coated steel, new roof slates to Vestry & South Porch plus new rainwater goods.

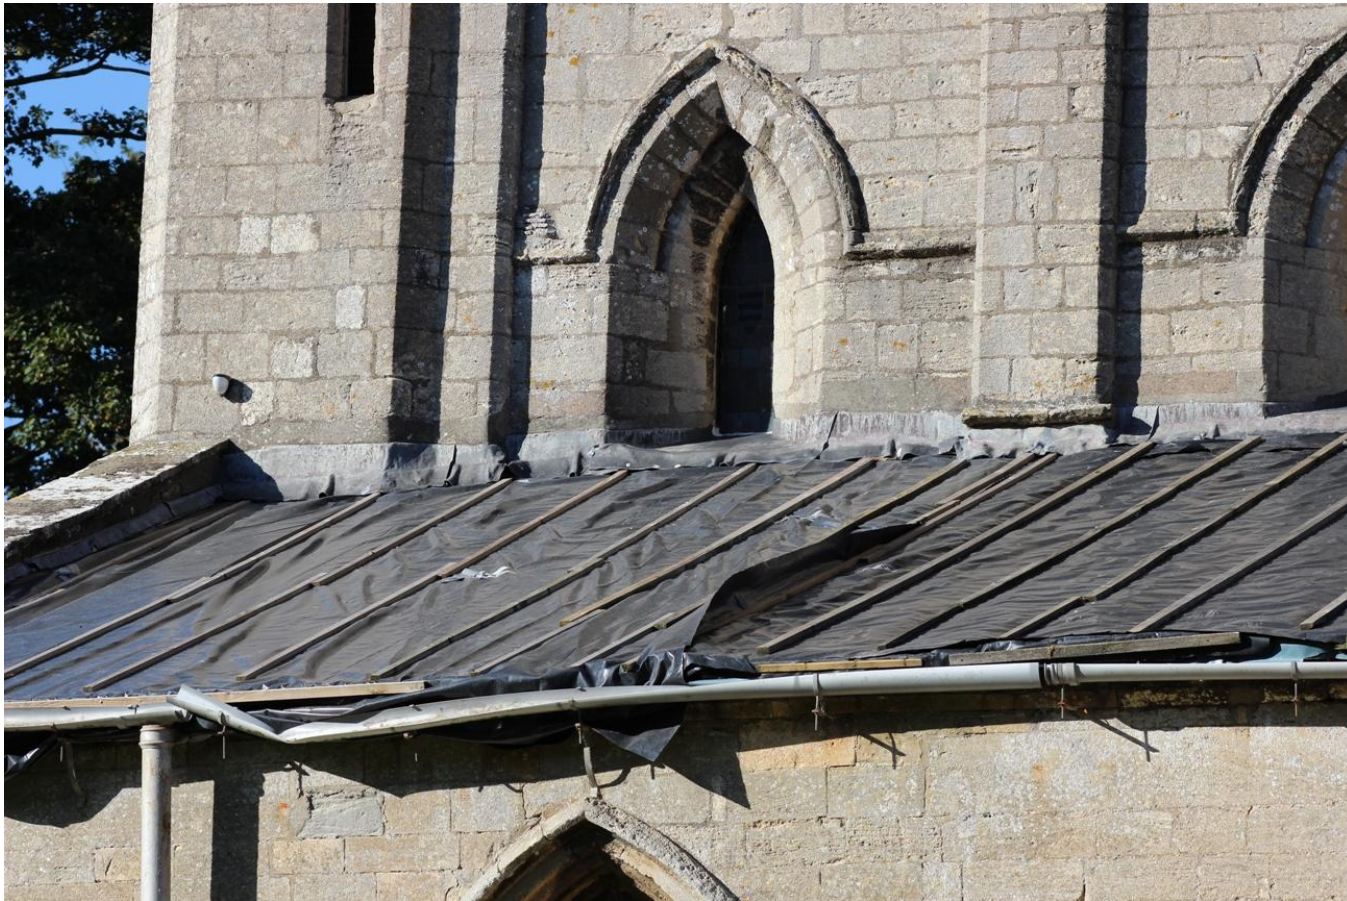
Rainwater Guttering and down pipes also needed replacement!

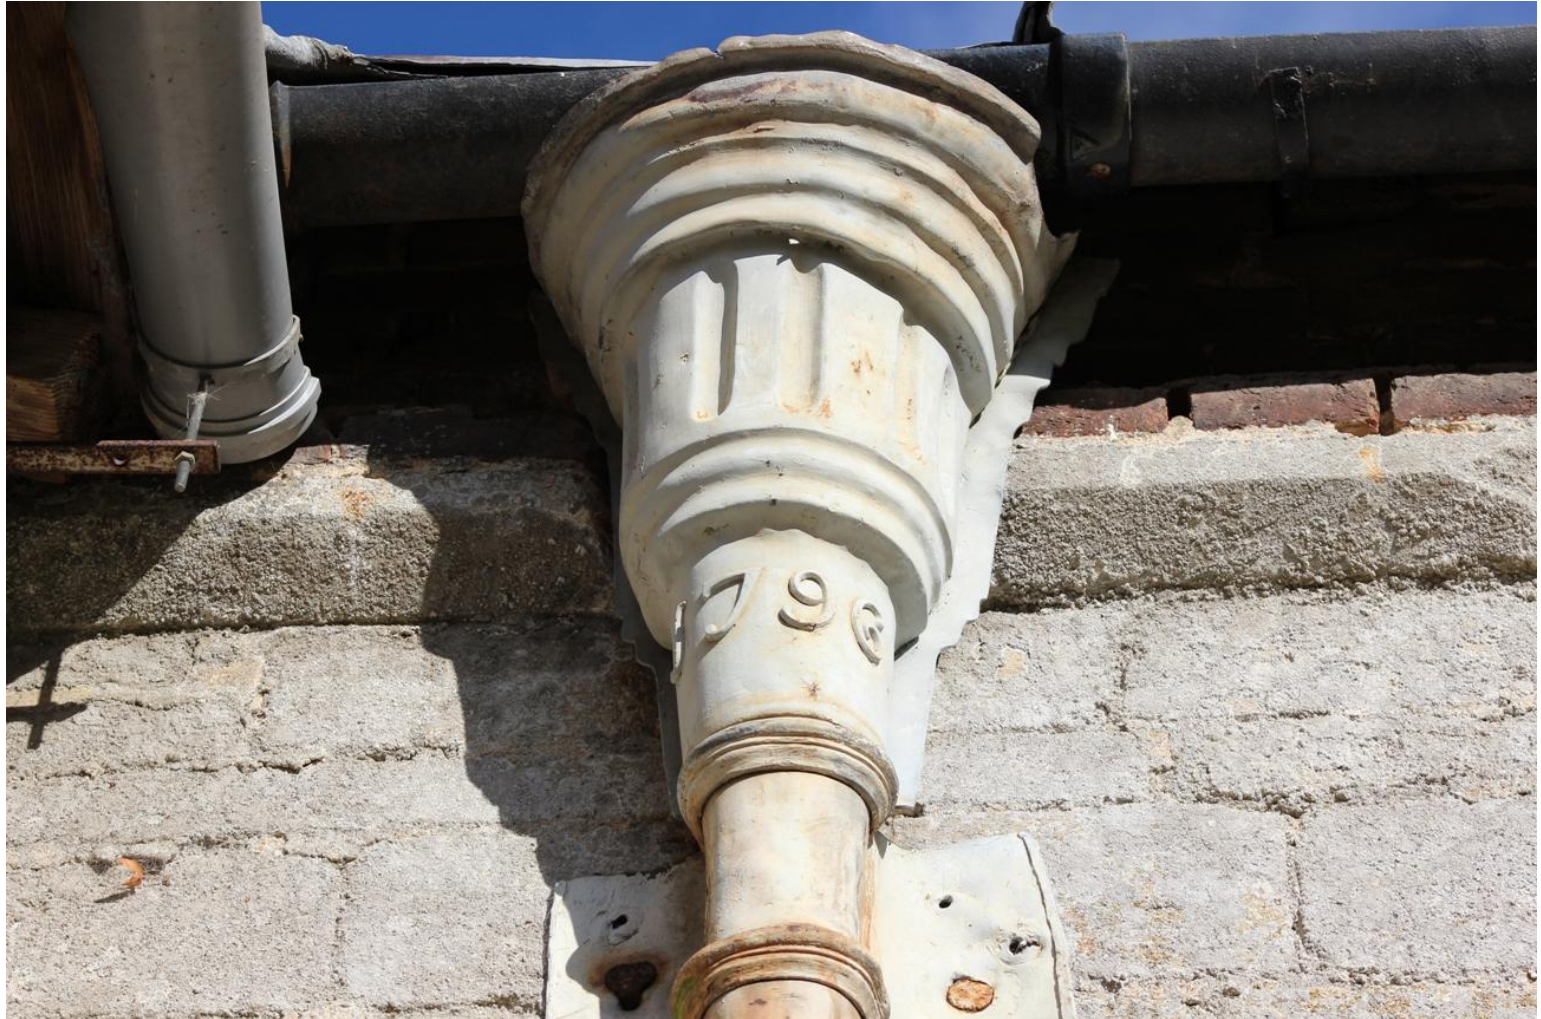
Considerations: Lead hopper ~ 1796

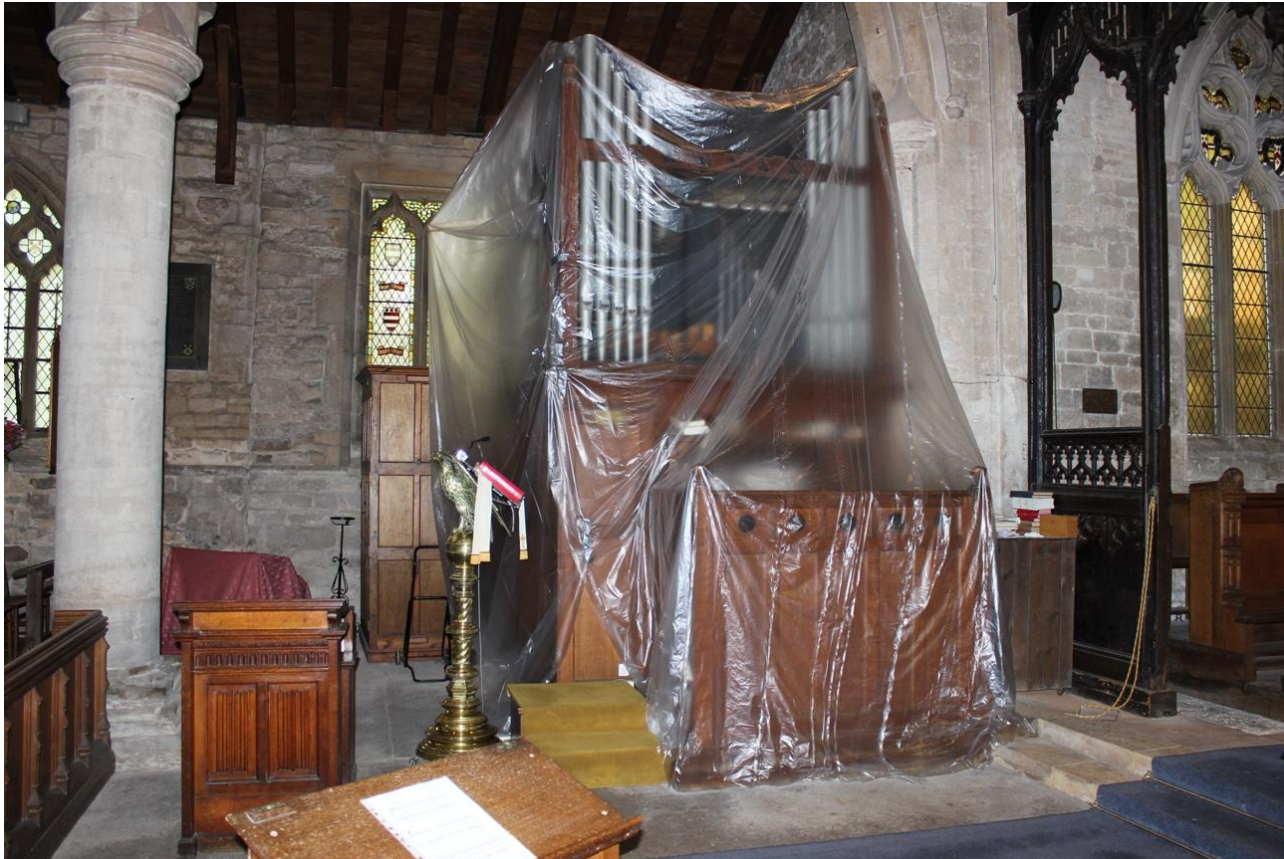
The Church Organ – required large pipe removal and storage. Plastic sheeting to cover over to prevent dirt and dust access. Requires full retune & works!
