St Mary's Church Frampton

Roof Repair Project

October 2015 -
January 2016

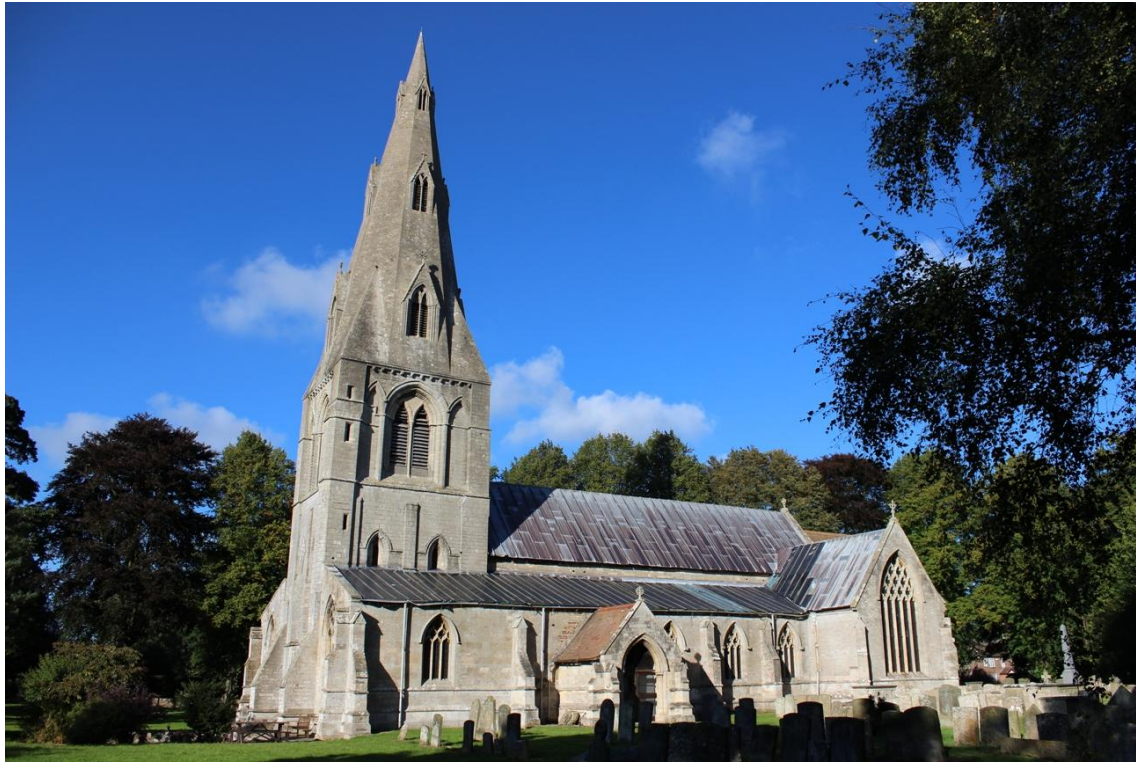
The church is in a remote location and on the south side is not overlooked for miles.

During 2 attacks in 2011 – thieves stole a large quantity of lead and also a section of the copper lightning conductor!

In 2014 there was a further attack when the lead over the Meeting Room area was stripped – allowing the rain to pour in on Palm Sunday (*despite new roof alarm*)!

The temporary roof covering of plastic sheeting was fitted to protect the roof timbers. It kept most of the rain out but a full repair was urgently needed!
